Earthquake Disaster Assessment on May 27 Ms 6.2 Yogyakarta Earthquake of Indonesia

**Qu Guosheng, Zhao Fengxin, Huang
Jianfa, Li Yigang, Li Yanfeng, Du
Xiaoxia and Ning Baokun¹**

**National Earthquake Response Support Service,
China Earthquake Administration
23, Oct. 2006**

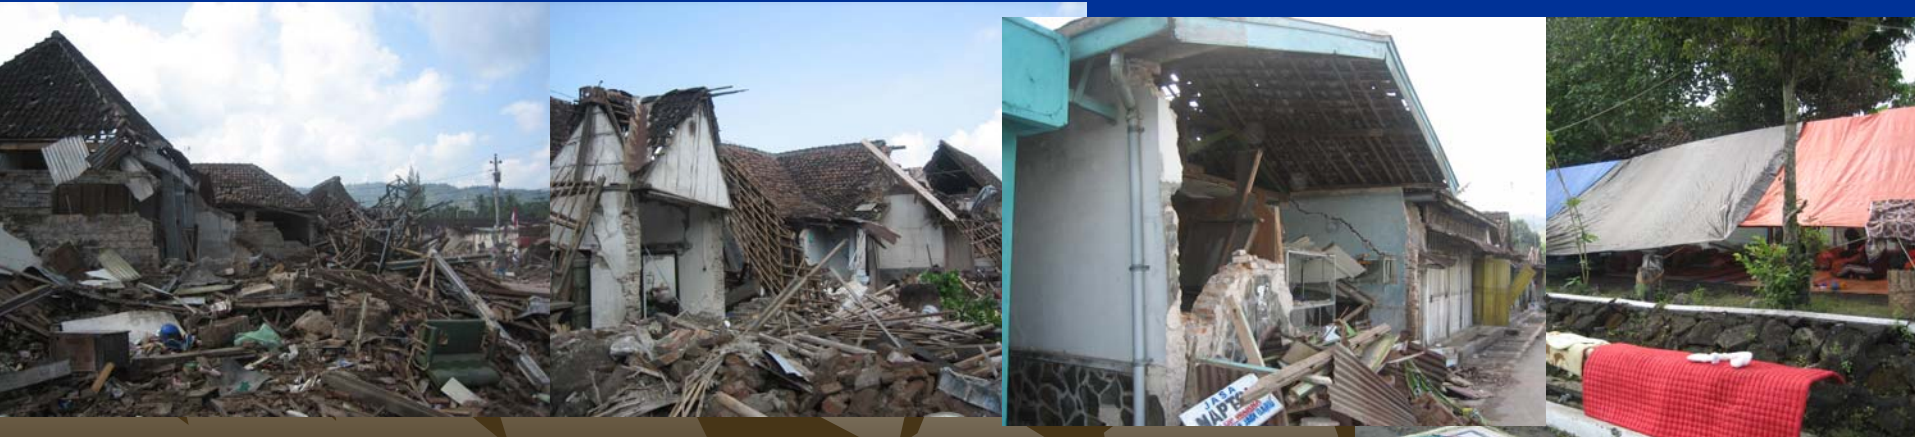
Imogiri is located in the east foothill area of the mountain and 90% of the houses in this area are heavily damaged and totally collapsed. The collapsed houses are mainly brick structure and the wall is very thin (120mm) with one layer of brick. The roof is usually made of wood and tiles. Many houses are collapsed in the center of Imogiri and the houses along the street are severely damaged. Compared to the east mountain area, more houses are collapsed in this area.

Pictures of damaged houses and disaster distribution in Imogiri

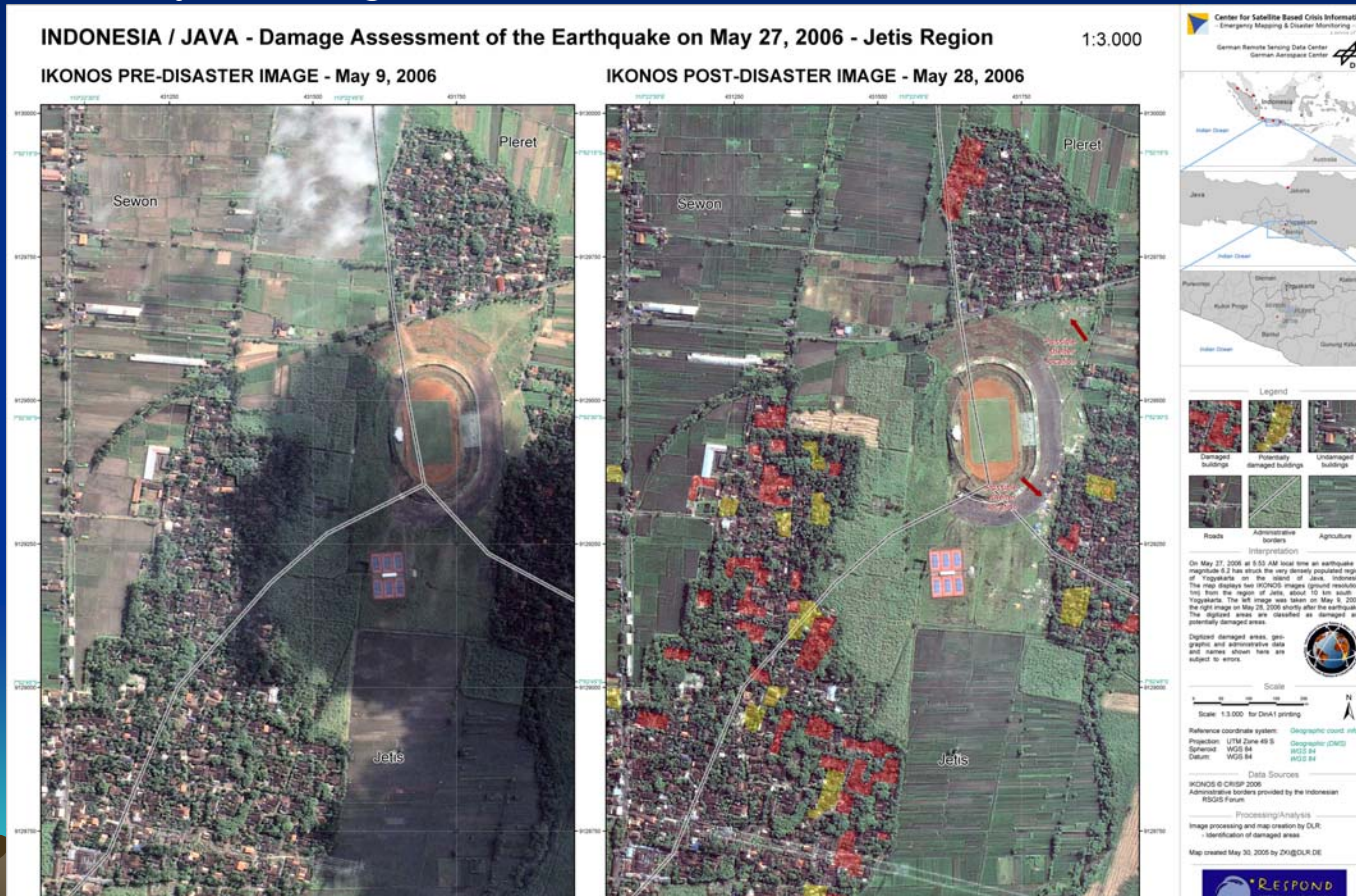
The interpretation of Quickbird images and field investigation indicate that 60% of the houses in Jetis are totally collapsed and 30% are severely damaged.

Pictures and image show the severely damaged area of Jetis

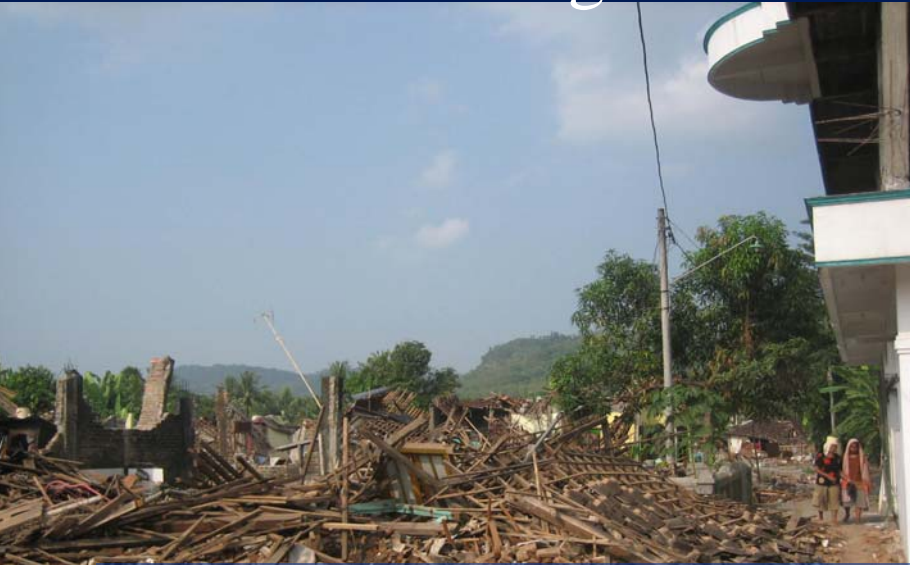
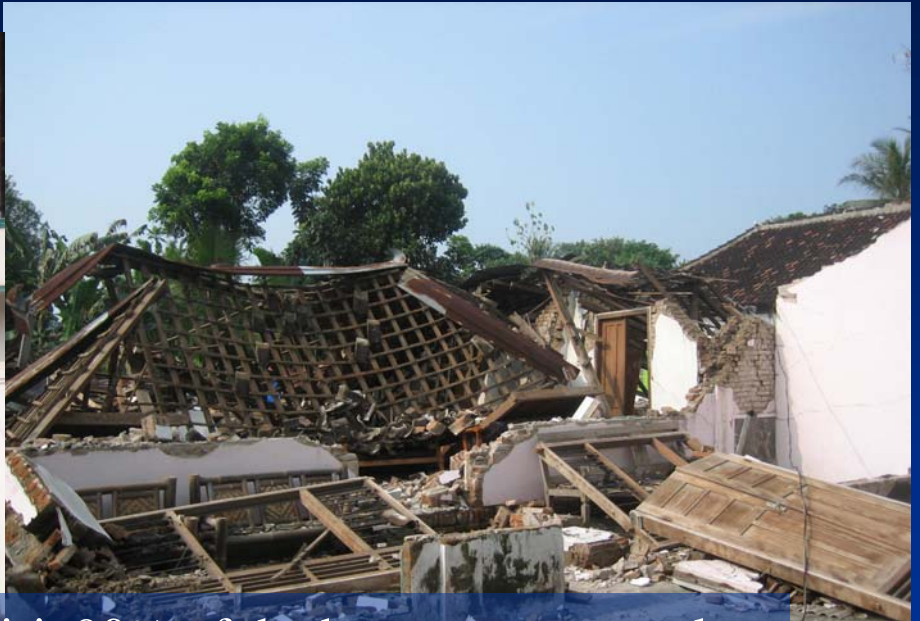
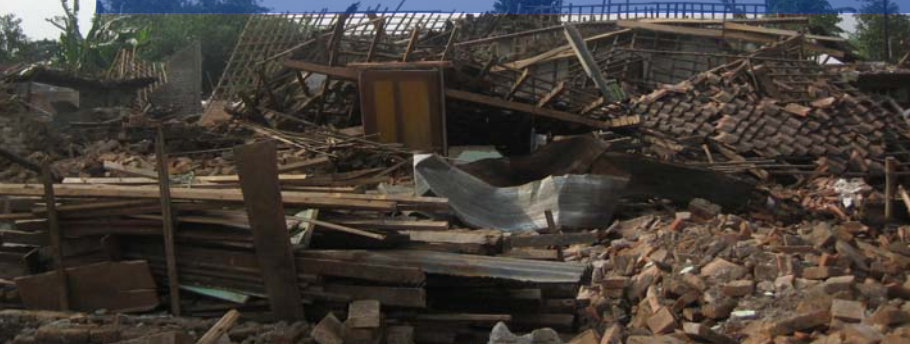
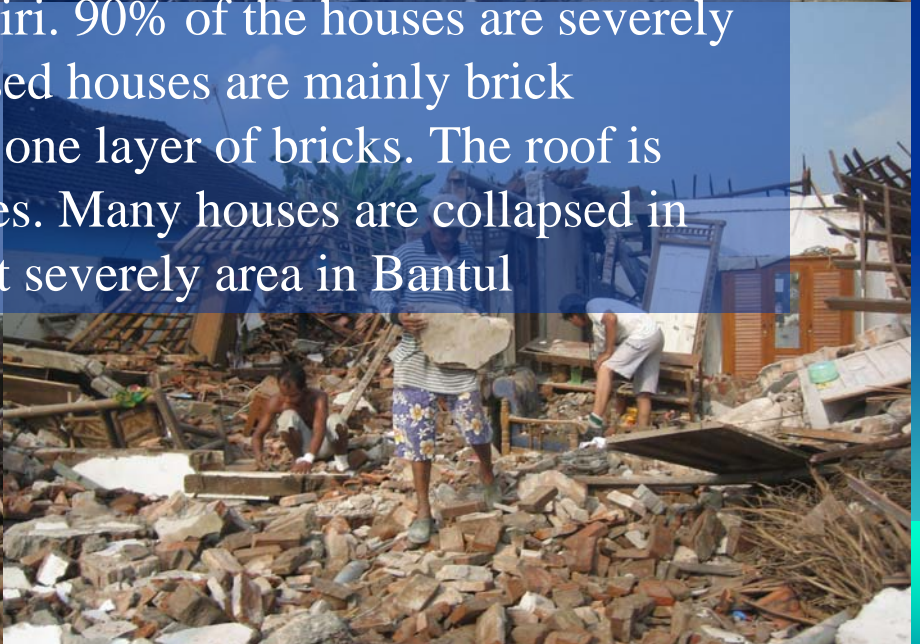
Pleret is located on the north of Imogiri. 90% of the houses are severely damaged or collapsed and the collapsed houses are mainly brick structure whose walls are made from one layer of bricks. The roof is made from woods and very heavy tiles. Many houses are collapsed in this area which makes Pleret the most severely area in Bantul

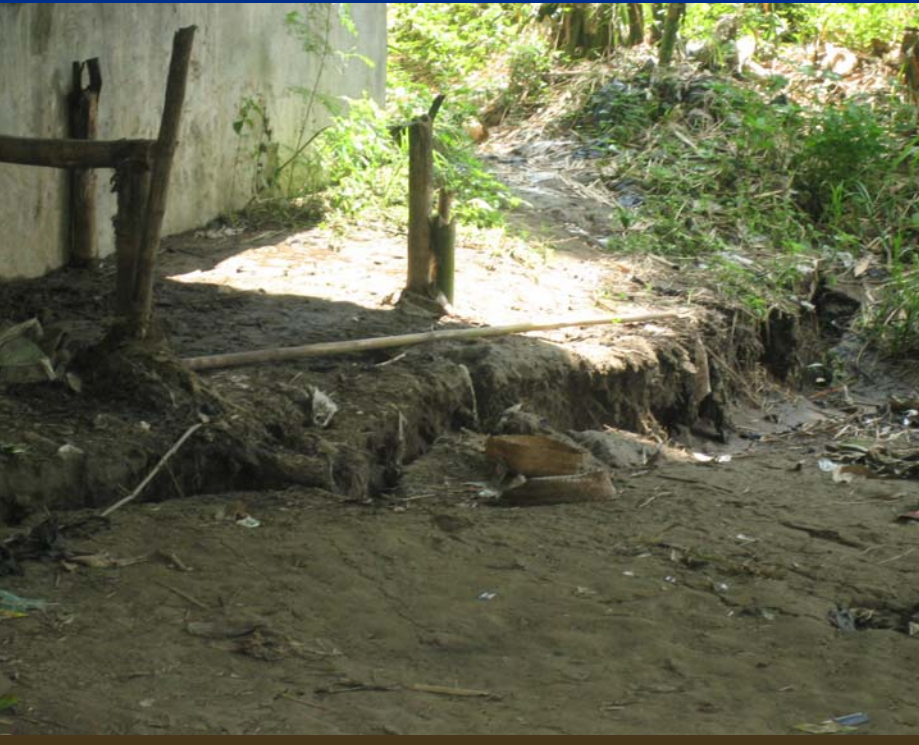
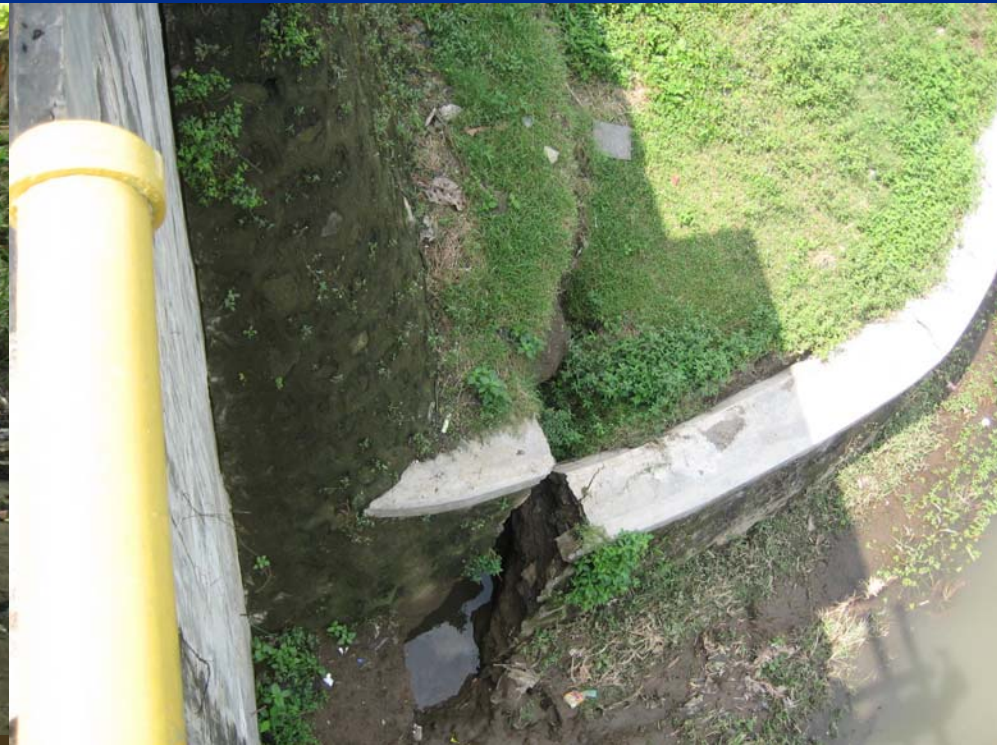
The situation of roads and bridges in the severely damaged area

Slope failure along the roads and break at the end of the bridges are found in Imogiri, Pleret and other severely damaged areas.

In the east of Imogiri, there are cracks on the piers of one bridge in the east of the river bank. In the west bank, slopes failures are found and need to be reinforced

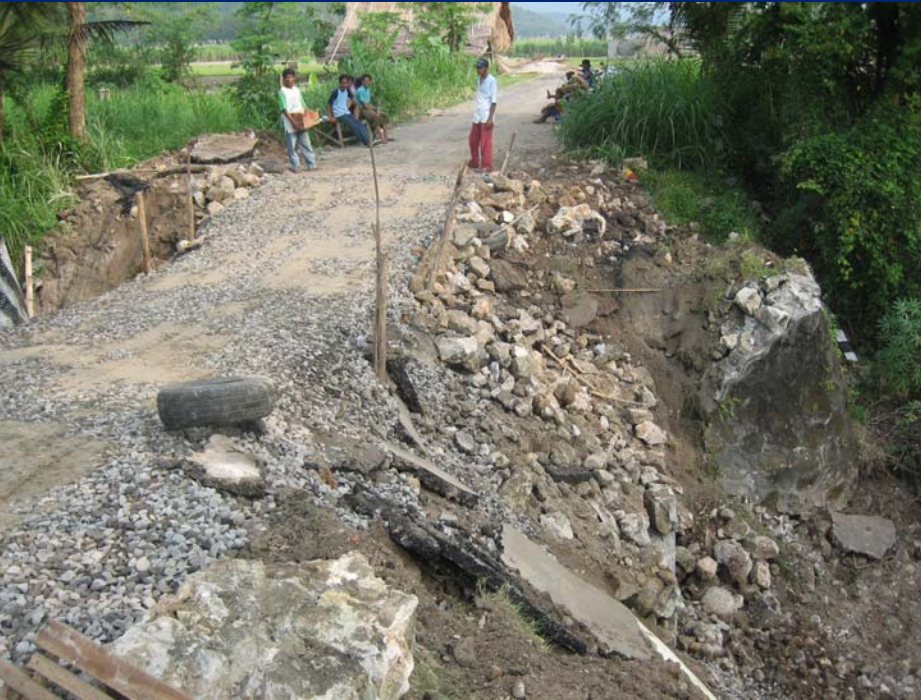
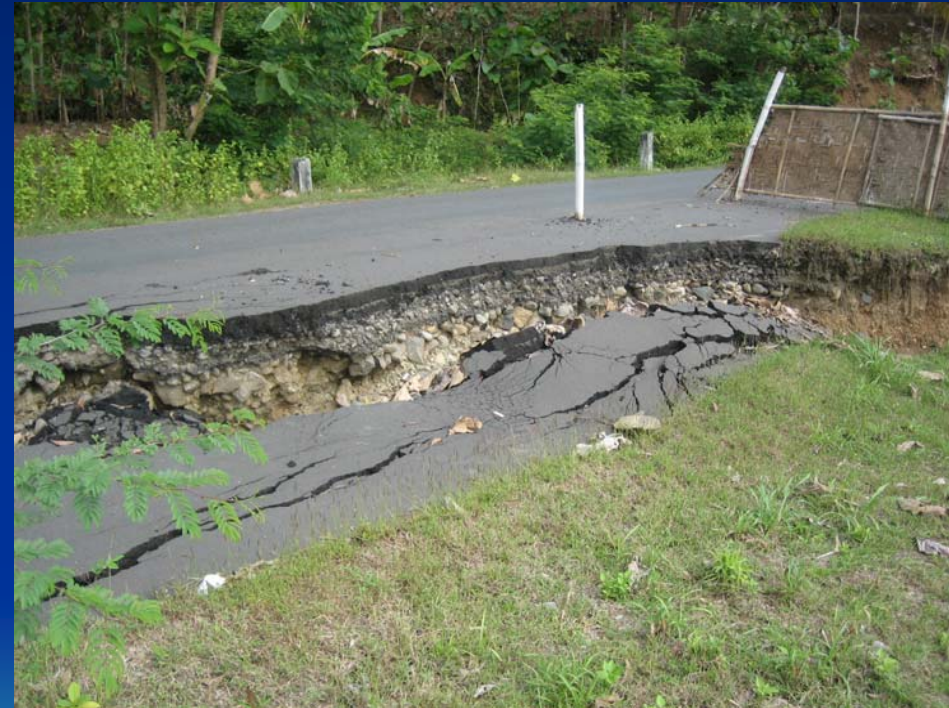
A 10-meter bridge was collapsed and has been repaired after the earthquake in the north of Pleret.

Slope failure of a roadbed is found in the south of Imogiri which will not affect the traffic after being repaired.

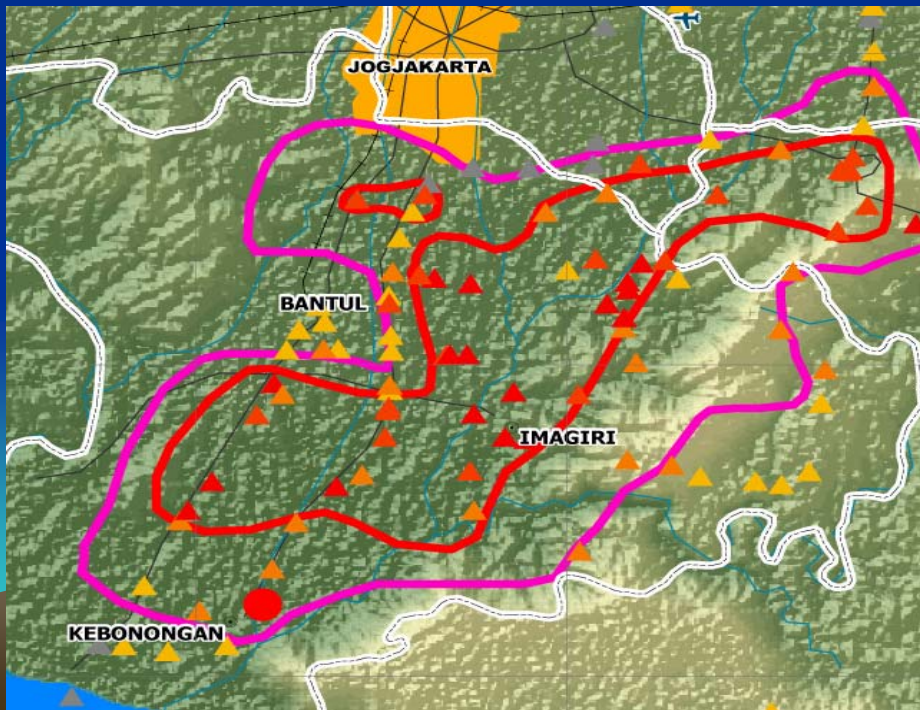
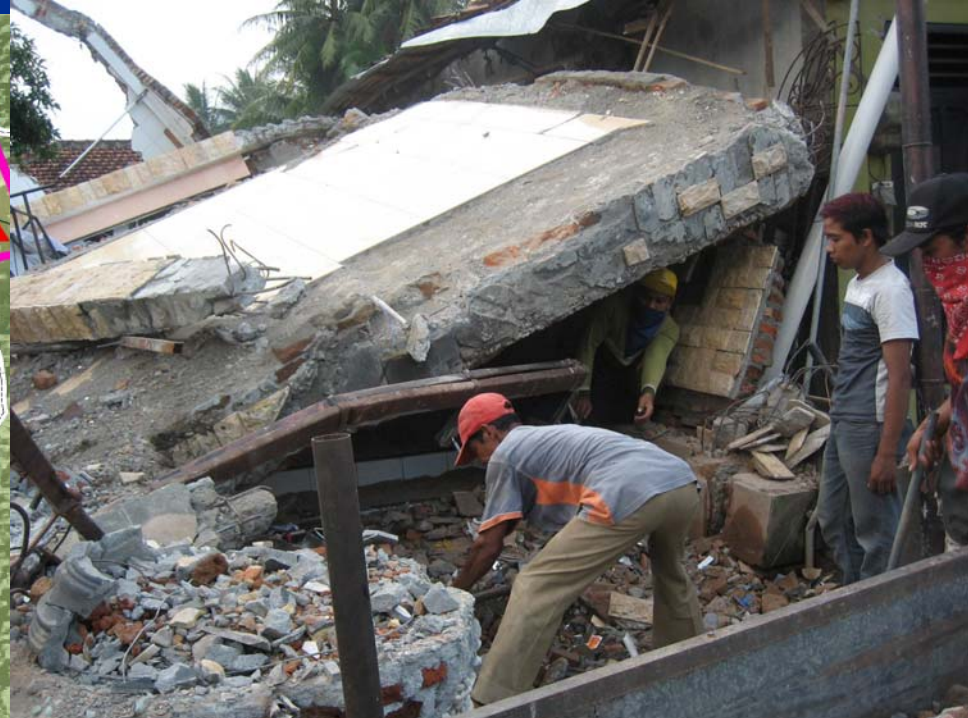
Outside the severely damaged area, including downtown Bantul, Sawanhan, Celep, Bun, Gadungan and other areas are moderately damaged where 30% to 50% houses are heavily damaged or collapsed and 30% to 50% are moderately damaged. The lifeline structures are without any damage.

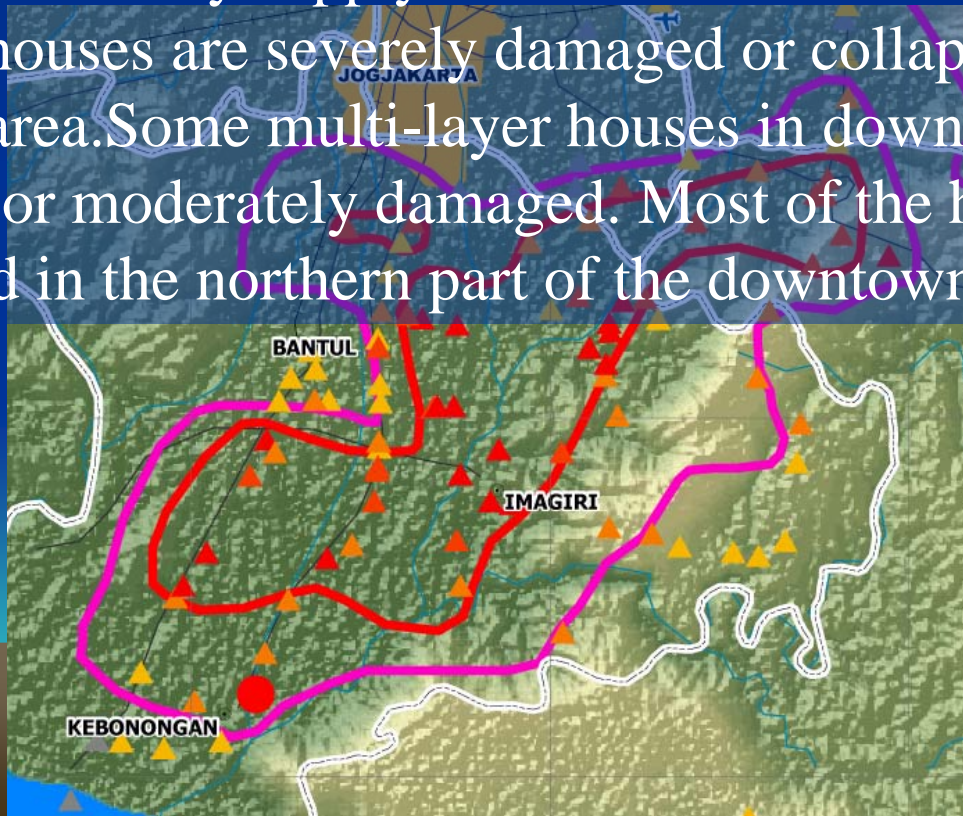
The areas in the eastern and southern parts of Bantul, from south of Celep to the Indian Oceanic beach, the western part of Bantul are the lightly damaged area. Landslide, slope failure and bridge bed failure are found, but the road and bridge are still passable. Electricity supply and communication are undamaged. Only few houses are severely damaged or collapsed in the mountain area. Some multi-layer houses in downtown Yogyakarta are lightly or moderately damaged. Most of the houses remain undamaged in the northern part of the downtown area.

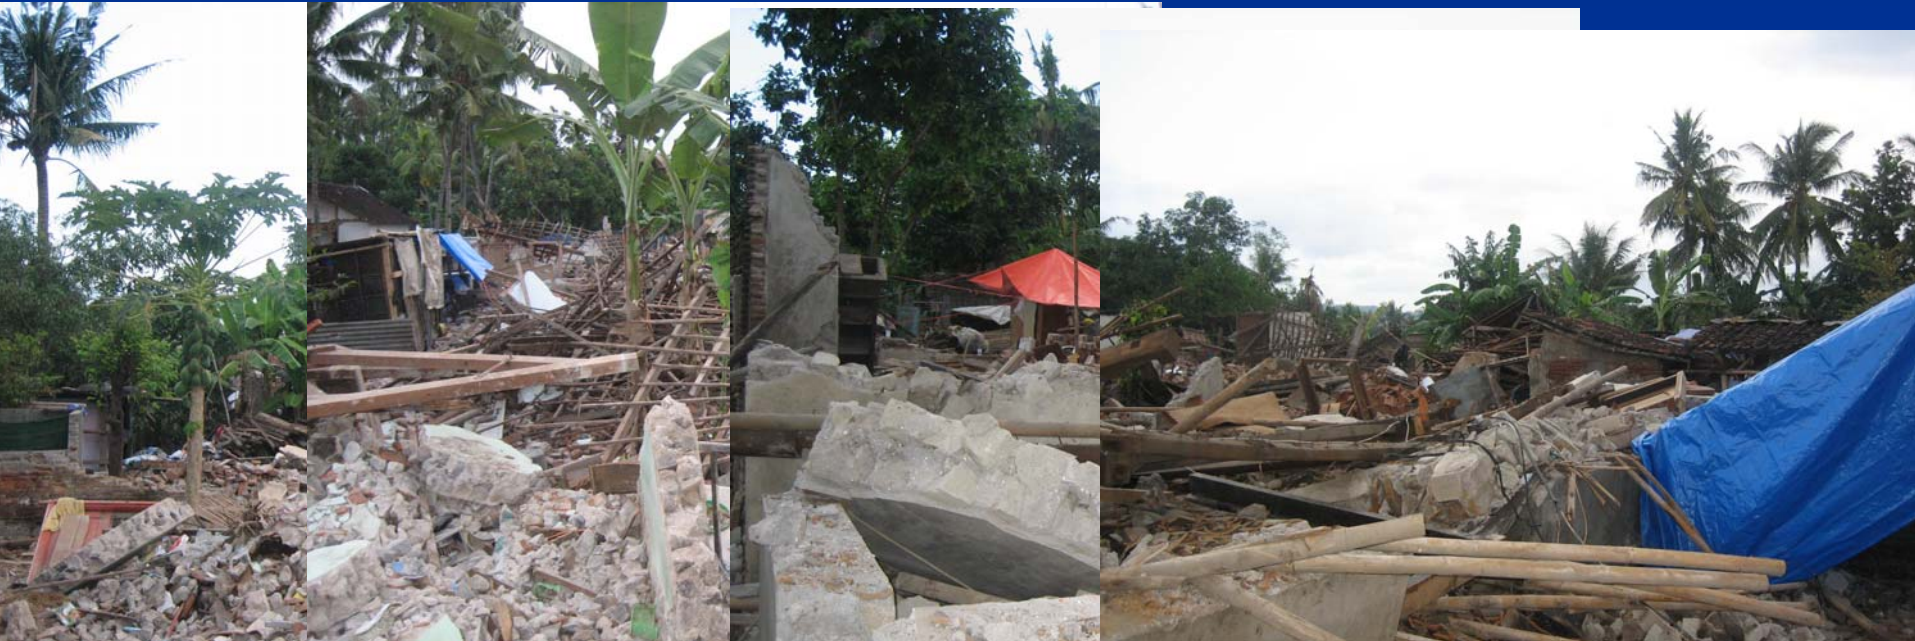
Poirin is located in the south of Kalasan - Klaten highway. 90% to 100% of the houses in this village are severely damaged or totally collapsed with one layer brick walls and roofs made from woods and tiles. Almost all the buildings in this village are collapsed which made Poirin the most severely damaged area in Klaten.

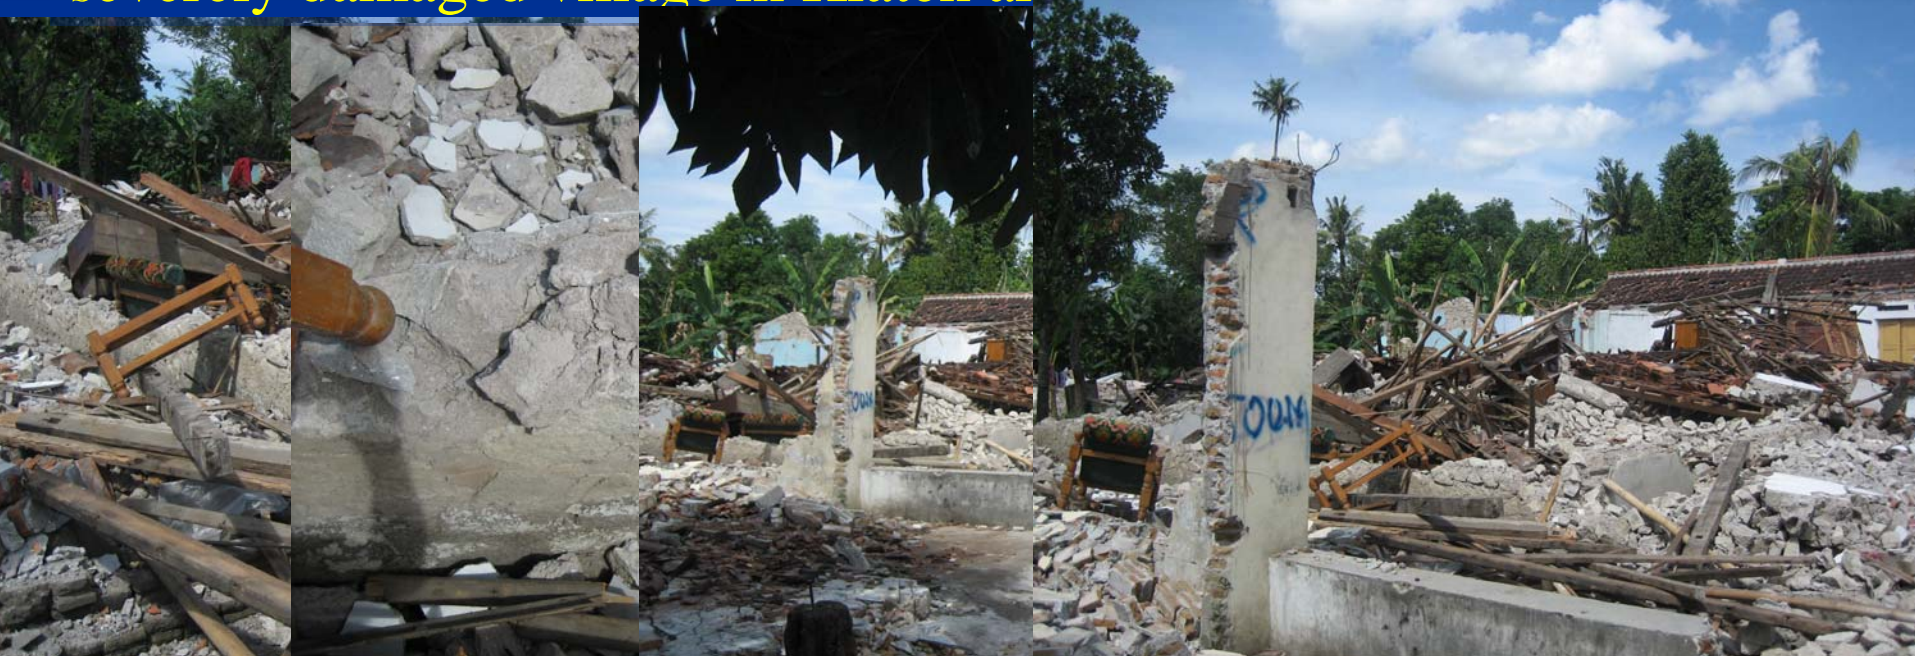
Mulwo Muru, RT 14/4 Klaten

These village are located in the south of Kalasan - Klaten highway. 90% of the houses are severely damaged or totally collapsed which are mainly made from tuff blocks. Thus tuff blocks have lower resistance ability and are vulnerable to the damage in the earthquake. Mulwo Muru and RT 14/4 Klaten is one of the most severely damaged village in Klaten area

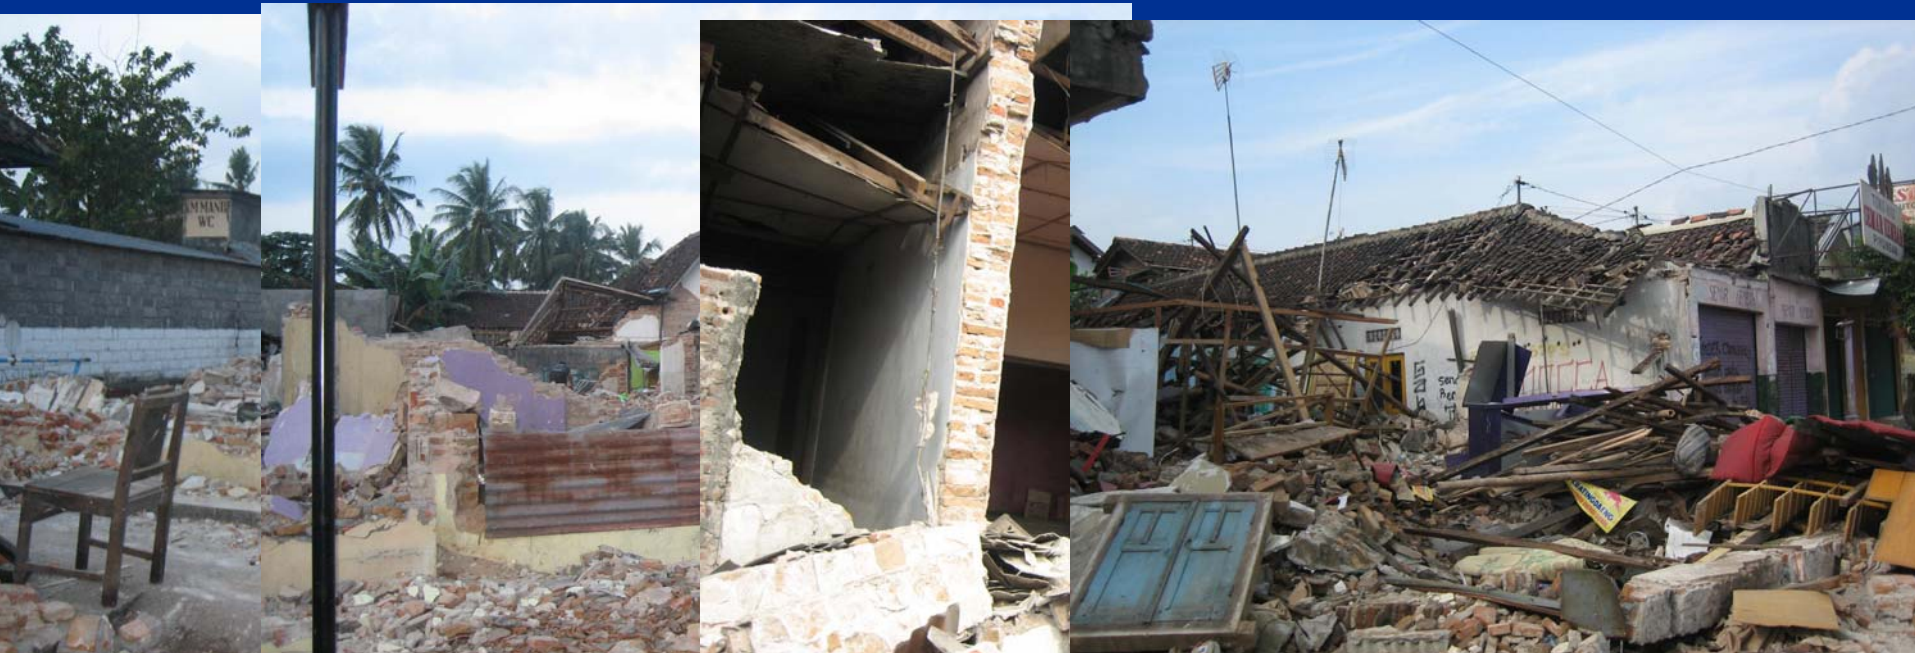
(1) Kalasan

30-50% houses are severely damaged or totally collapsed. The collapsed houses are mainly one layer brick structure. Walls and roofs of house made from woods, bricks and red tiles. Kalasan is one of moderately damaged area of Klaten area.

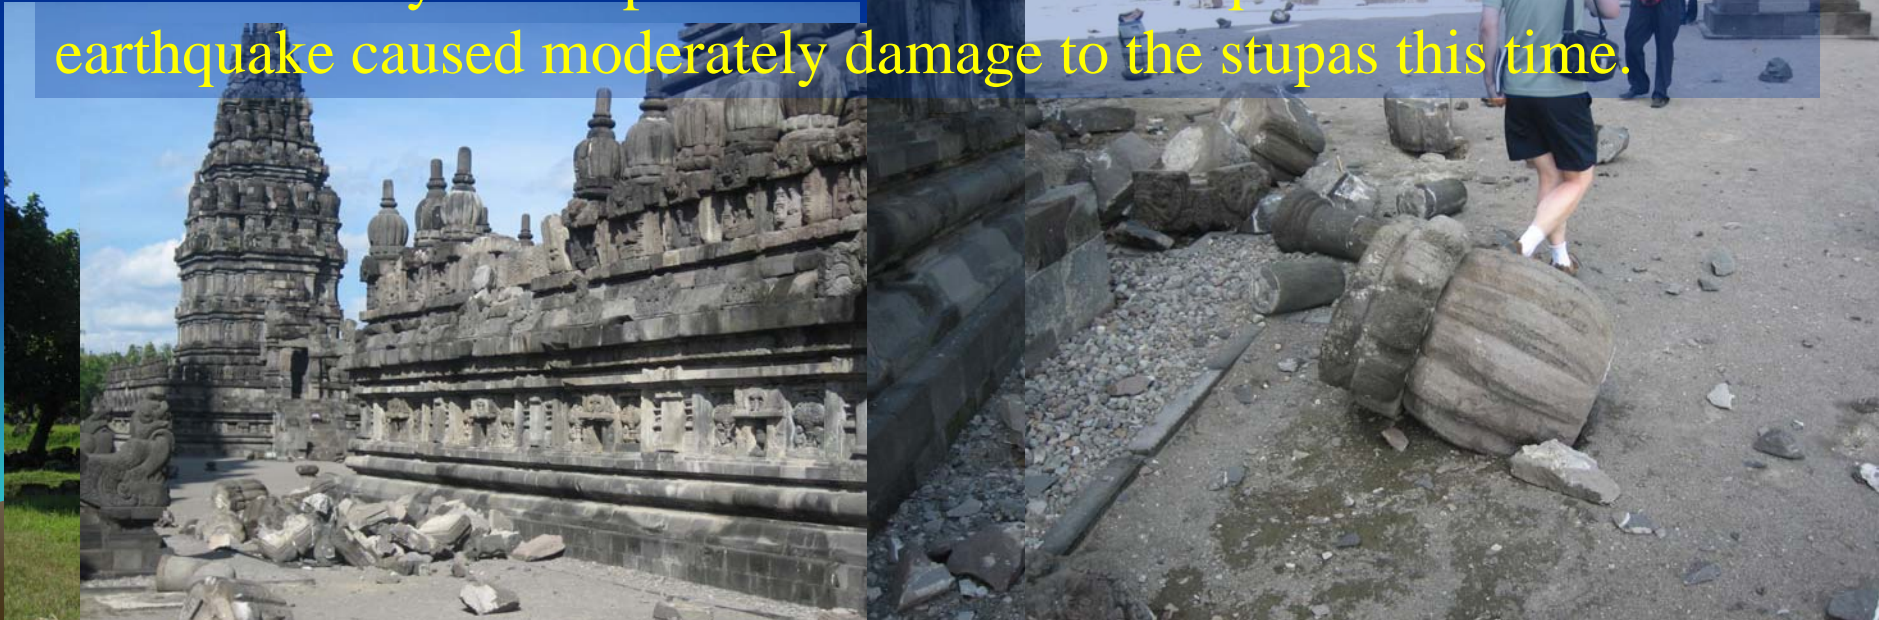
(2) Prambanan Temple

The Hinduism Prambanan temples are on list of the world culture heritage list, which compose of more than ten stupas with the height from 10 to 40 meters. More than 500 pieces of stones from the stupa are detached by the earthquake in which almost 400 pieces are from there main stupas. Some cracks are found on the foundation of the stupas. These stupas are built from tuff stones in the 8th century and experienced several earthquakes afterward. The earthquake caused moderately damage to the stupas this time.

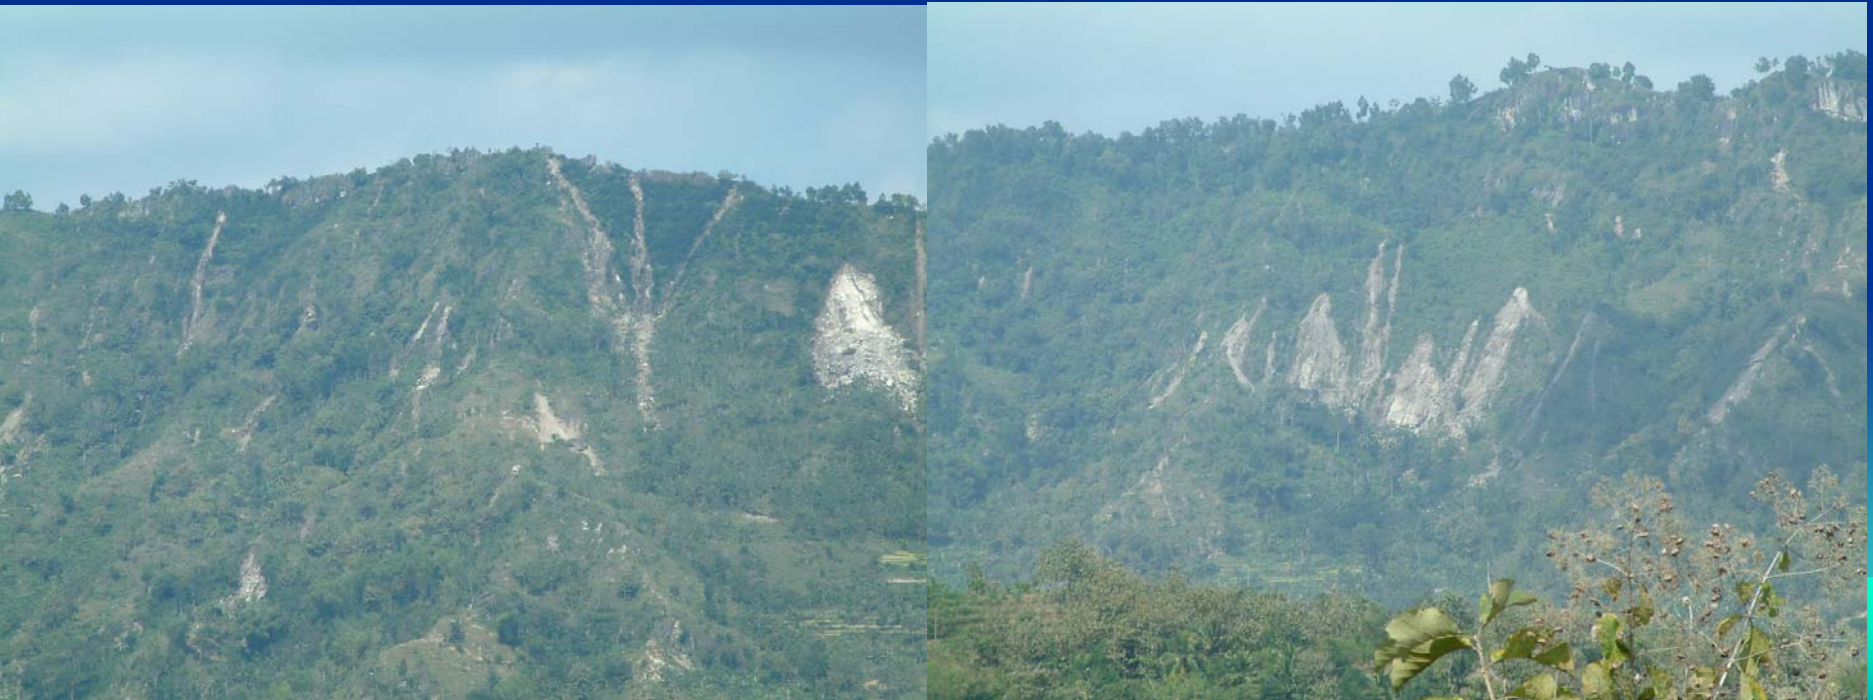
(5) The southern mountainous area

There are more than 200 small to middle scale landslides in this area. The landslides are mainly on the north slope of the mountains and stop at the middle of the mountain slope (Fig.21). No damages are caused to those villages in the foothill of the mountains.

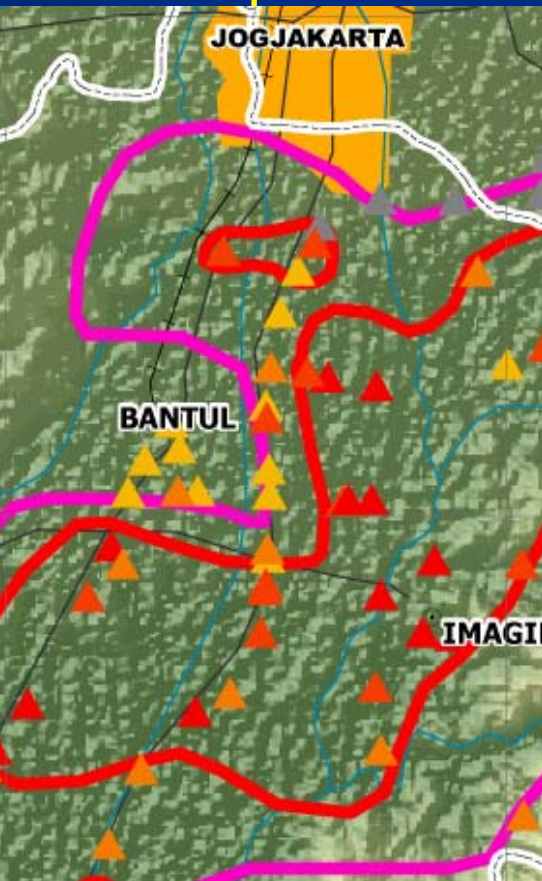
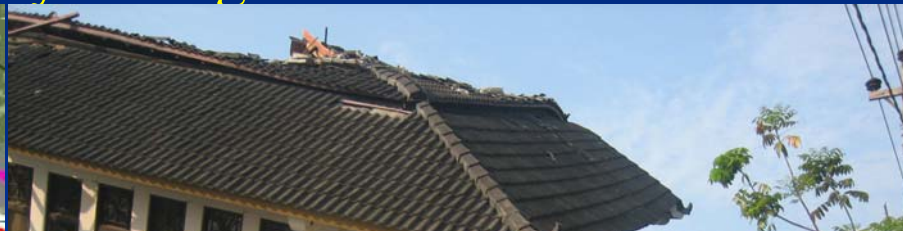
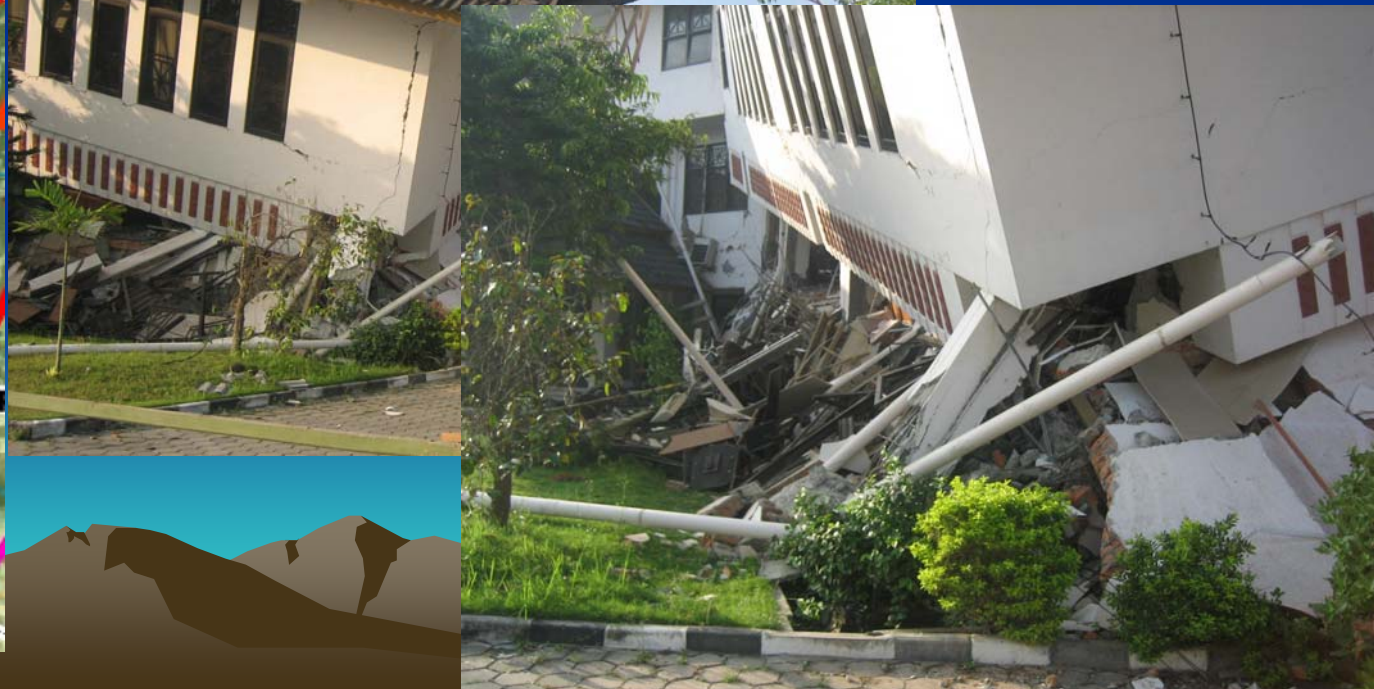
Jarakan damaged area are located on the north of Bantul, this is a relatively small severely damaged area where a three-story office building is collapsed (Fig.22) and some brick houses are also collapsed or heavy damaged.
