Earthquake Disaster Assessment on May 27 Ms 6.2 Yogyakarta Earthquake of Indonesia

**Qu Guosheng, Zhao Fengxin, Huang
Jianfa, Li Yigang, Li Yanfeng, Du
Xiaoxia and Ning Baokun¹**

**National Earthquake Response Support Service,
China Earthquake Administration
23, Oct. 2006**

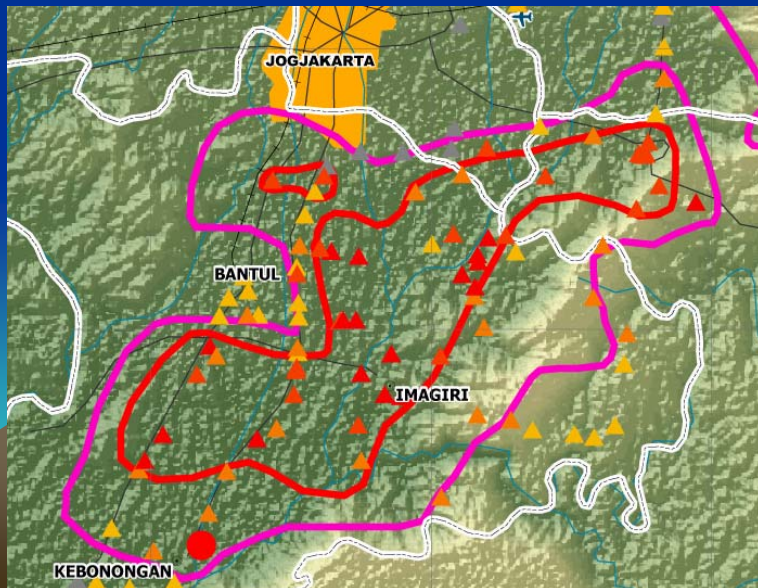
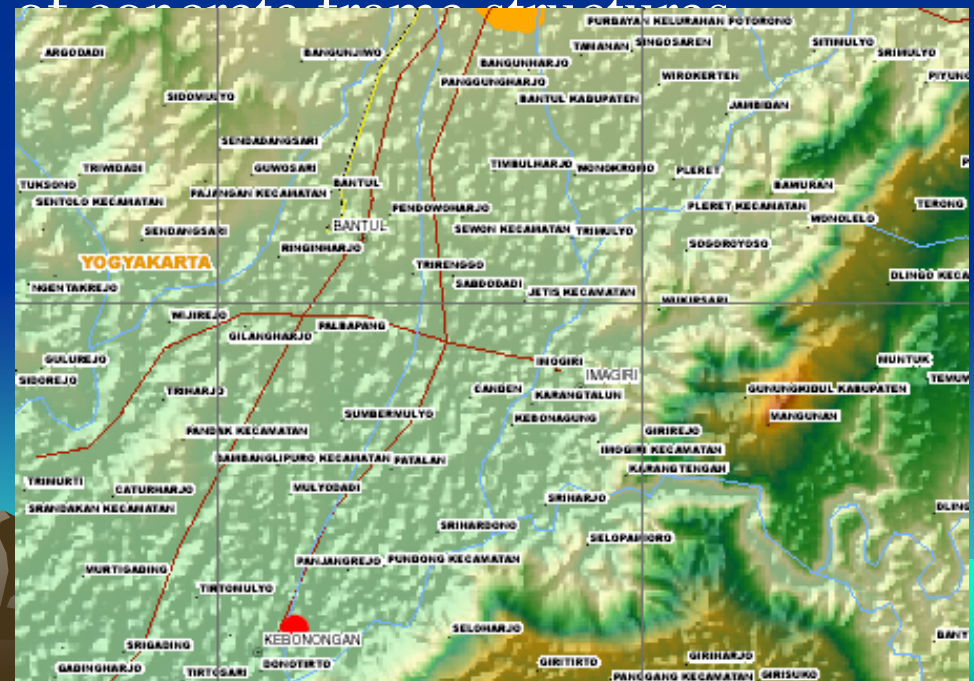
1. Bantul damaged area

1) Heavily damaged area: Heavily damaged area are mainly distributed in the southern, eastern, and northern part of Bantul along the foothill and basin area with the direction of NE, from Sewon in north to Pundong in south, including Jetis, Imogiri, Sewon, Pundong, Pleret and Bangonpapan et al. Heavy damaged and collapsed houses are about 80-90%. Houses in this area are mainly wood or brick structure with some of concrete frame structures.

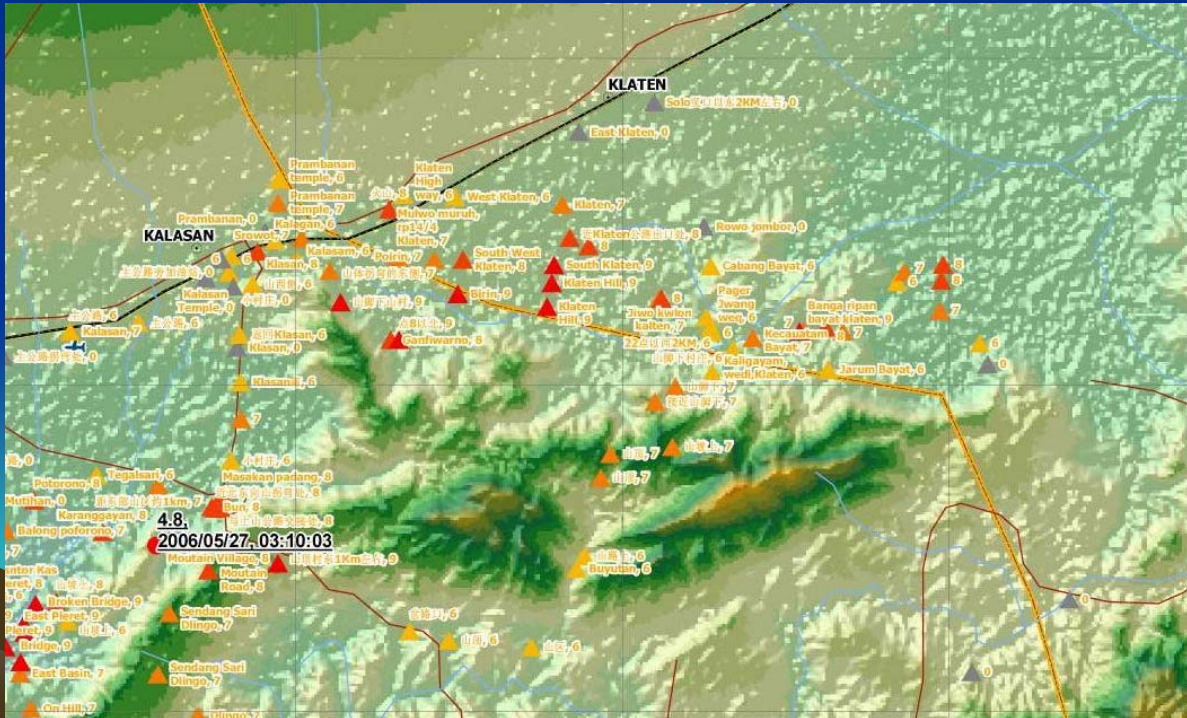
1) Heavy damaged area

The heavy damaged area distributed in the southern and western part of Klaten, along the plain of foothill of mountain, with a strike of northwest to east-west. The villages located in the eastern part of foothill of NW small mountains in south of Kalasan and the villages in south of the Kalasan-Klaten highway are also heavily damaged.

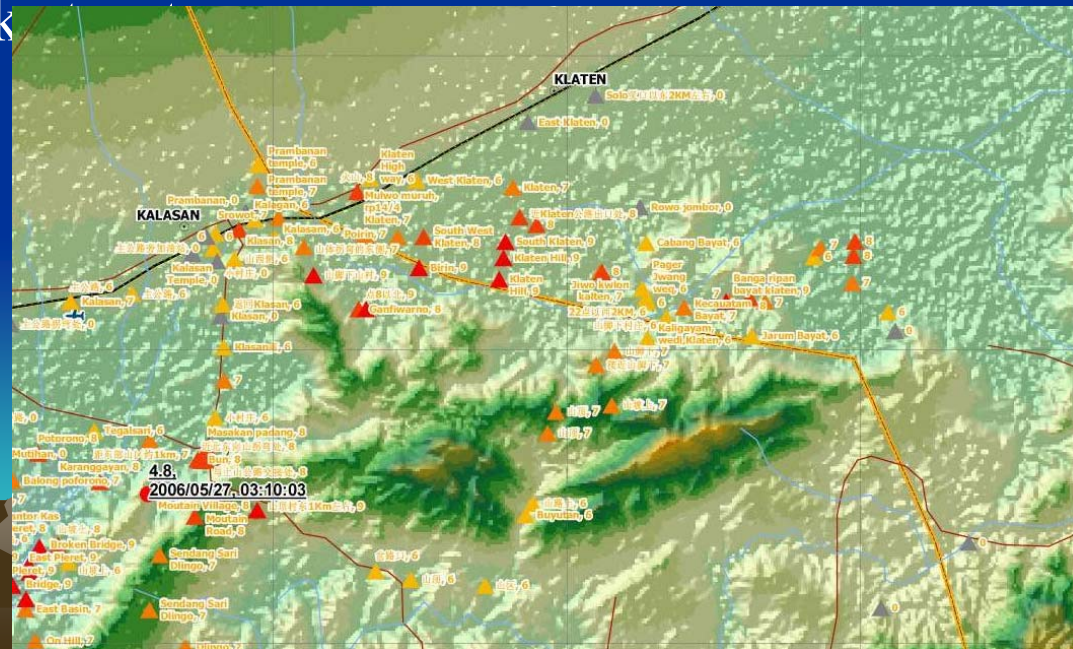
1) Heavy damaged area

To the southeast of Klaten, the damage is decreasing. The severely damaged villages in Klaten area include Gantiwarno, Poirin, Tegalrejo etc.. Intensity in the area are from VIII to IX and almost 60% to 80% of the houses are severely damaged or collapsed. Poirin is the most severely damaged area, where the intensity reached IX and over 90% of the houses are severely damaged or totally collapsed. The types of houses are mainly wood or brick

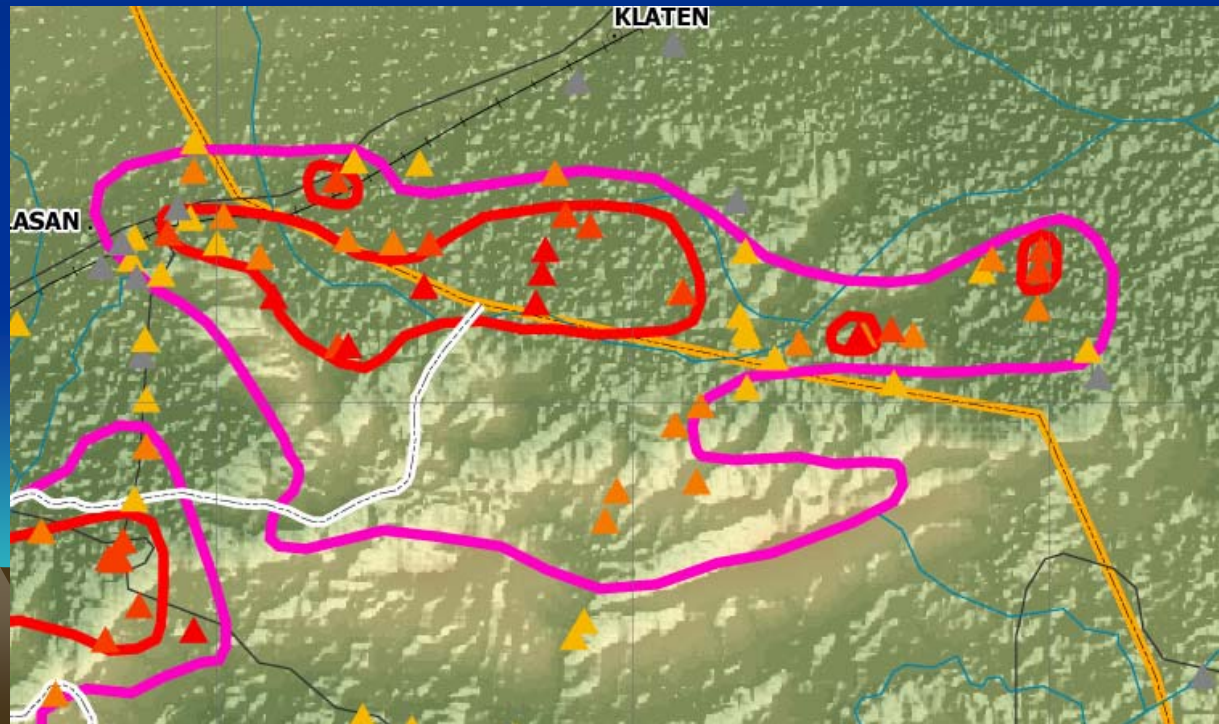
2) Moderately damaged area

Outside the heavy damaged area, including Kalasan, Prambanan Temples, south side area of Kalasan - Klaten highway, Jarum Bayat are moderate damaged area. 30% to 50% of the houses are severely damaged and collapsed. The lifeline systems are almost undamaged. There are about 200 landslides in the south mountain areas.

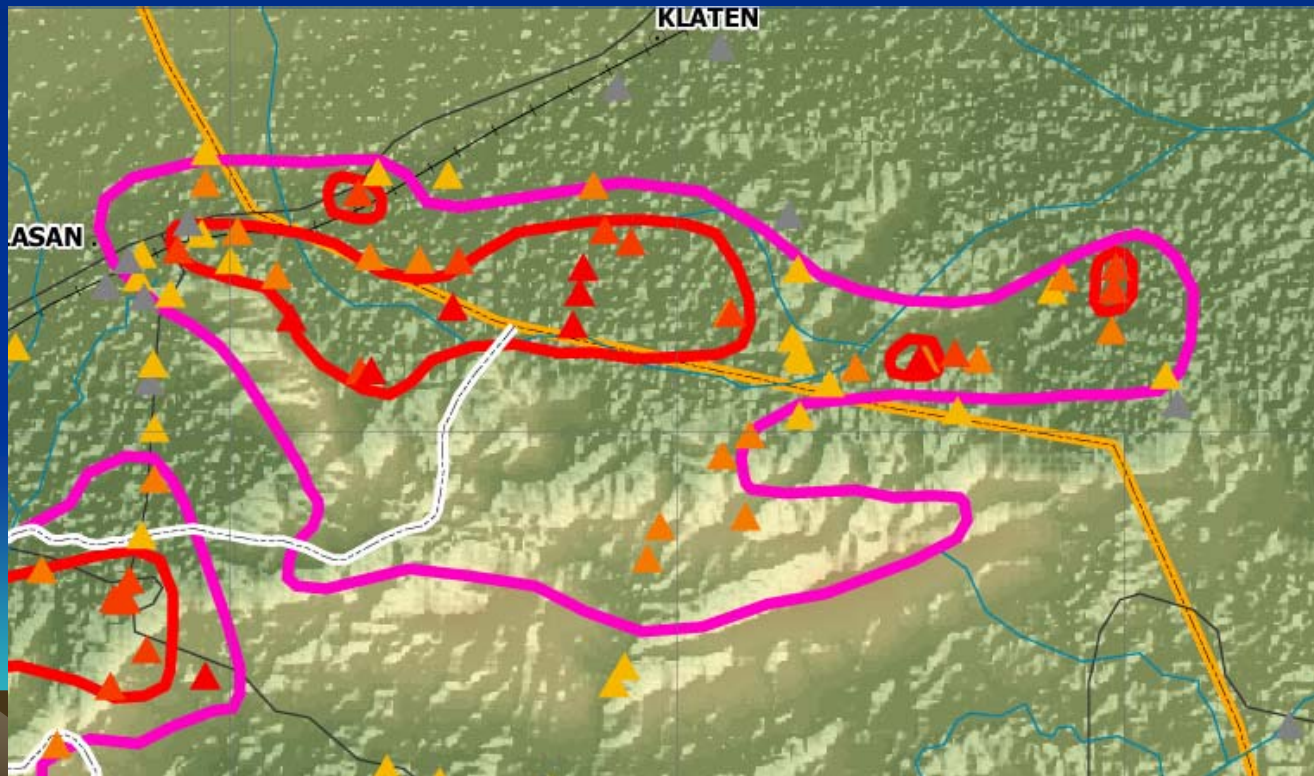
3) Lightly damaged area

The area in west and north of Kalasan, Klaten and the area close to the Kalasan-Klaten highway, the southeast area of Klaten and the south mountain area are lightly damaged.

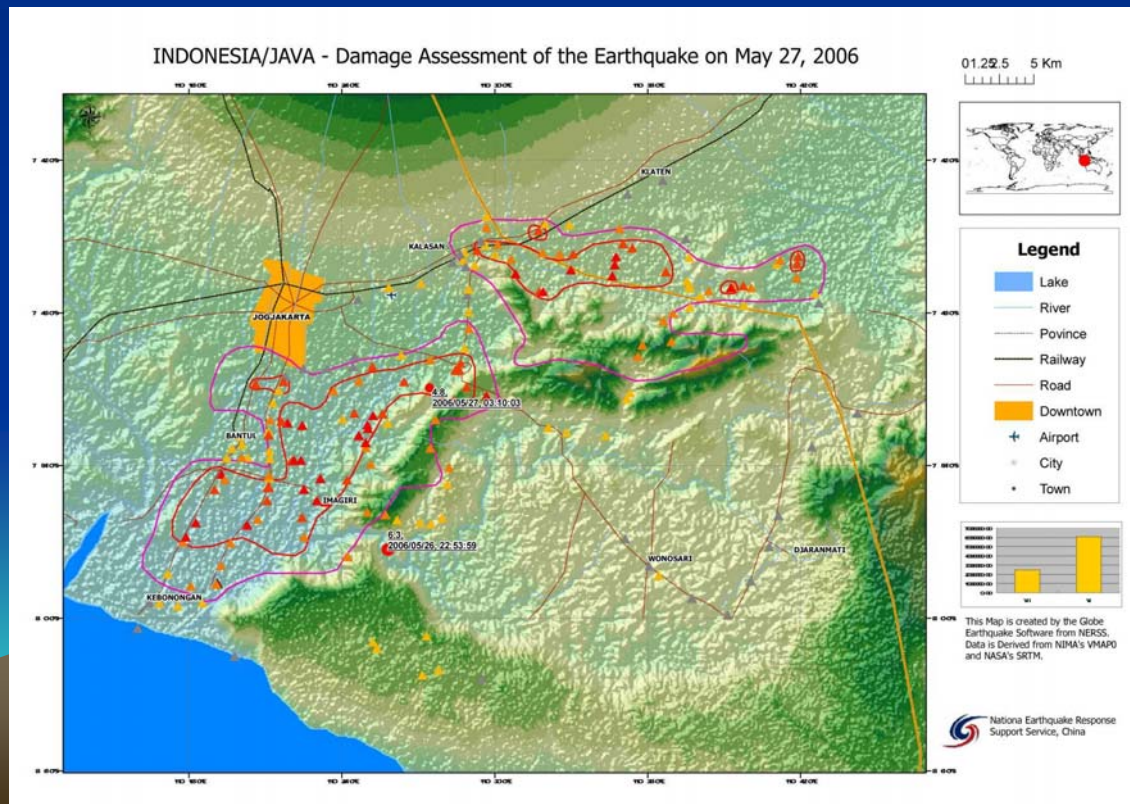
4) Comprehensive earthquake disaster assessment

Figure shows the earthquake disaster degree and distribution mainly from the results of disaster investigation, as well as disaster interpretation results from high resolution satellite images and disaster evaluation results from UNOSAT.

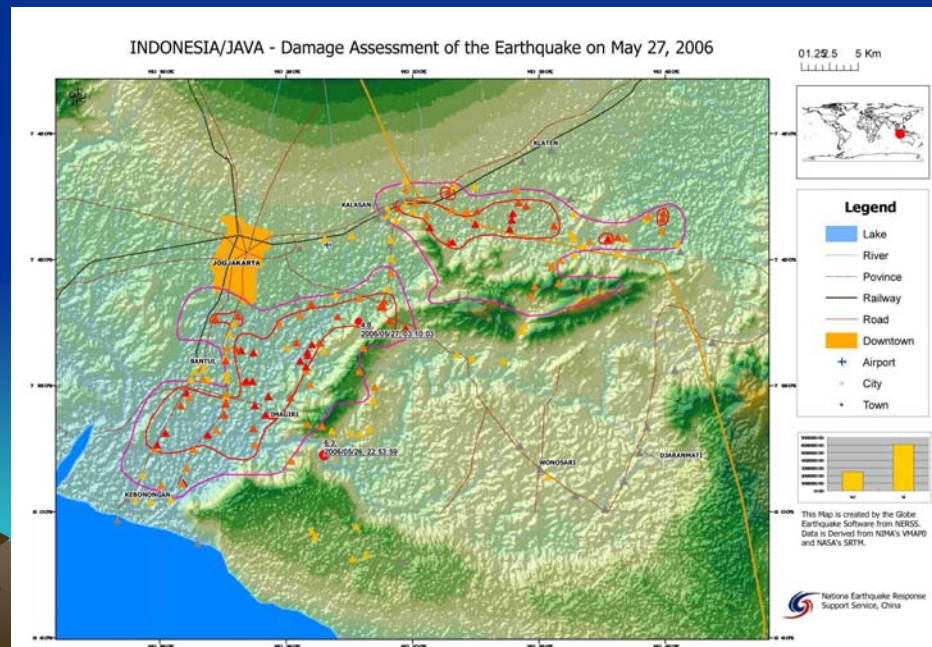
1) Bantul severely damaged area

(1) Macro-epicenter is located between the alluvial plain and foothill on the east of Bantul which trends from southwest to northeast where 80-90% buildings are collapsed and severely damaged.

(2) The mountain areas on the east and southeast are near the relocated epicenter by USGS where the buildings are damaged slightly.

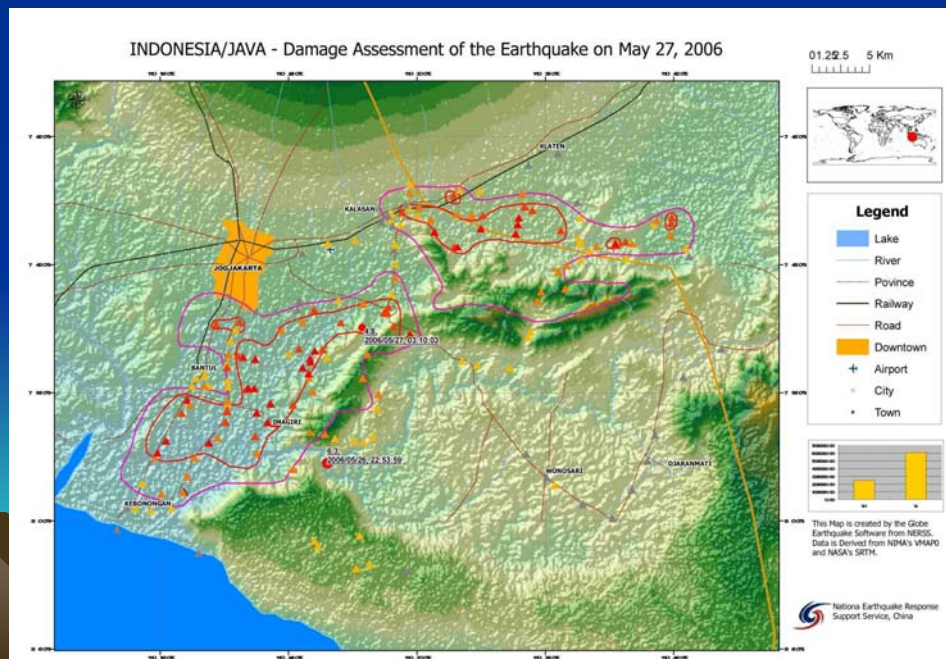
(3) There are obvious difference of the damages between the mountainous areas and alluvial plains on the east of Bantul reflecting the aggravated damages by the basin effect.

(4) The losses along the streets are obviously severe in most damaged area which is caused by big open space for shopping activities.

(5) The most damaged and collapsed building type is one-layer wooden or brick houses with thin walls and heavy roofs.

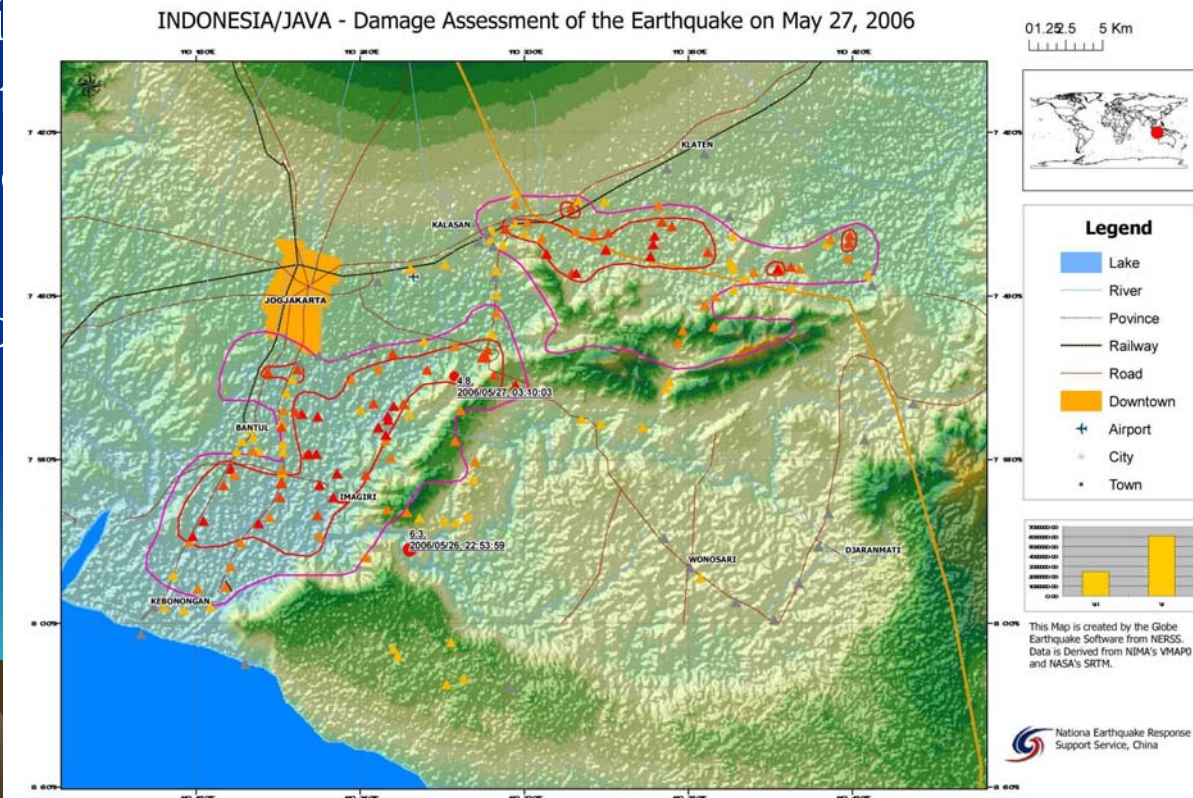
2) Klaten: The heavily damaged area

(1) Most damaged area lies in the alluvial plain between the southern Klaten and mountainous area which trends west-east and north-west along the basin in front of the foothill, where 80-90% buildings are heavily damaged and collapsed.

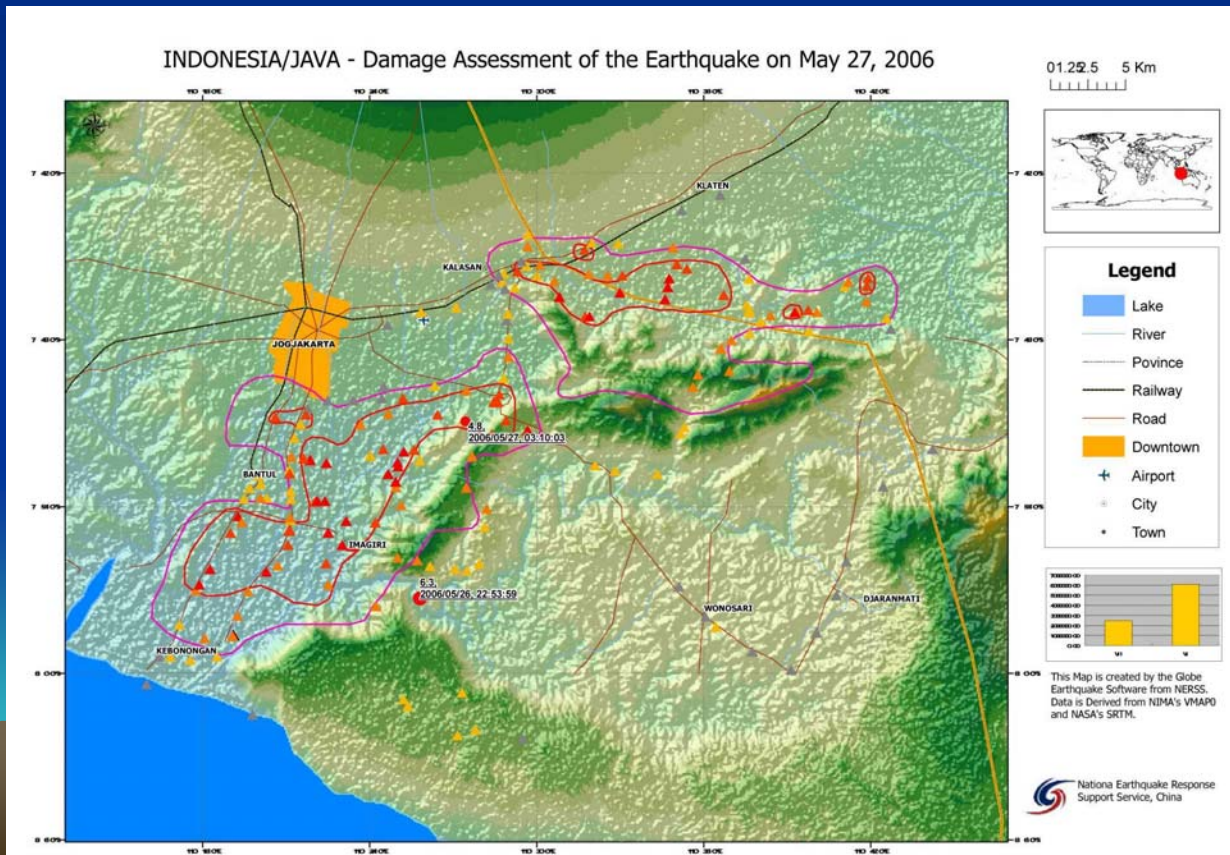
(4) The loss along the streets are obviously severe in most damaged area which caused by big open space for shopping activities.

(5) The most damaged and collapsed building type is one-layer wooden, tuff blocks, or brick houses with thin walls and heavy roofs.
